## FIRE PROTECTION SYSTEM DURING DISTURBANCES CAUSED BY LIGHTNING STROKE

**Abstract** – Modern fire protection systems realize many functions. First one is to signal and remotely inform when fire appears. Second one is to turn on extinguishing system also very important. Lightning strike to the building lightning protection system or nearby can be dangerous for fire protection system installed inside this building. Any malfunction of this system can cause large financial damage by needlessly turn on or not turn on the extinguishing system.

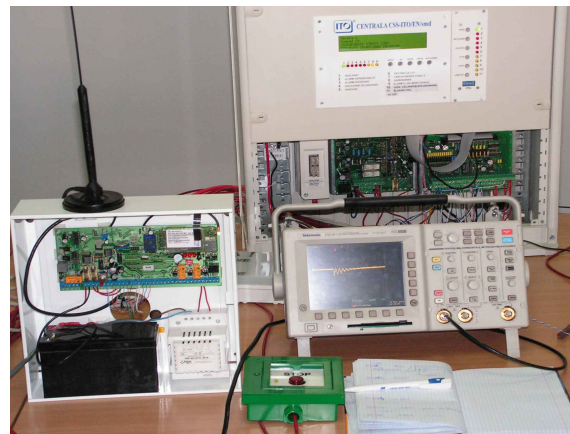
All tests were performed on the real fire protection system, which consists of digital automatic control and indicating central, 2 fire warning sensor lines with 8 standard fire sensors, 1 laser fire detector – 1000 times more sensitive than standard one, helper systems, GSM data exchange system and status printer (Fig. 1).

Fig. 1 - Fire protection system during the EMC tests.

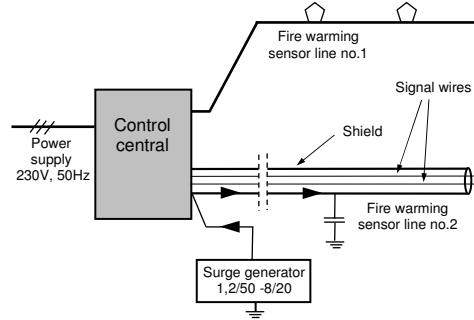
- a) Shield of signal cable 20 m away from FPS. To couple the generator with signal line capacitor 10 nF was used.
- b) Shield of cable with direct connection of generator to shield. Distance between putting point and FPS - 20 m.
- c) Between signal wires and shield,
- d) Between signal wires.

Fig. 3 - Risk caused by surge current in the shield.

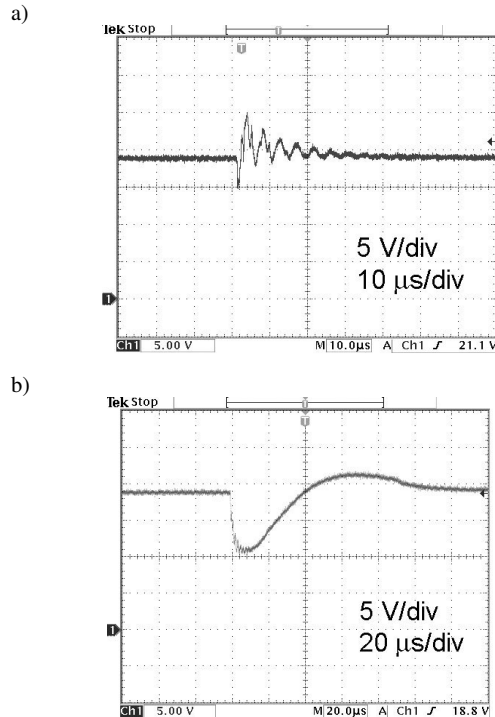
Some examples of overvoltages between wires caused by surge currents and voltages in are presented in Fig. 5 and 6.

Fig. 5 – Overvoltages observed between two signal line wires. Source of disturbances - surge generator 2 kV in arrangement: a) surge generator - shield - capacity 10 nF, b) generator - shield.

Overvoltages between wires reached the values from ten to twenty volts when the surges are putted in to shield of sensor line. For surges putted between signal wires and shield larger values of overvoltages were observed. In this case the impulse voltages which appeared in signal ports of control central reached:
