## FLAGSTAFF AS AN AIR-TERMINATION ROD MEASUREMENTS RESULTS

**Summary:** Main purpose of this paper is to present flagstaff as the lightning air-termination rod. Examples of damages caused by surge current are presented. High current surge generator was used for testing purposes. Photography-based discussion about flagstaff mounting, typical errors is presented.

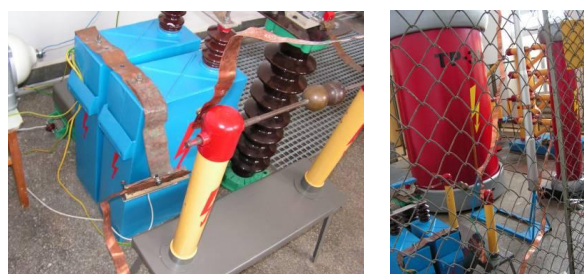
**Fig. 2.** Surge generator in the high voltage laboratory

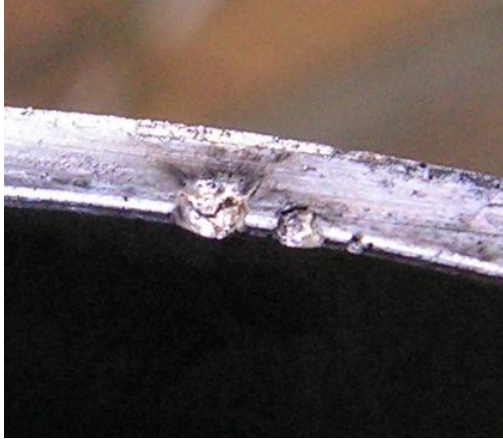
**Fig. 4.** 8/20 $\mu$ s 1kA surge current result on the flagstaff interconnection point between sections

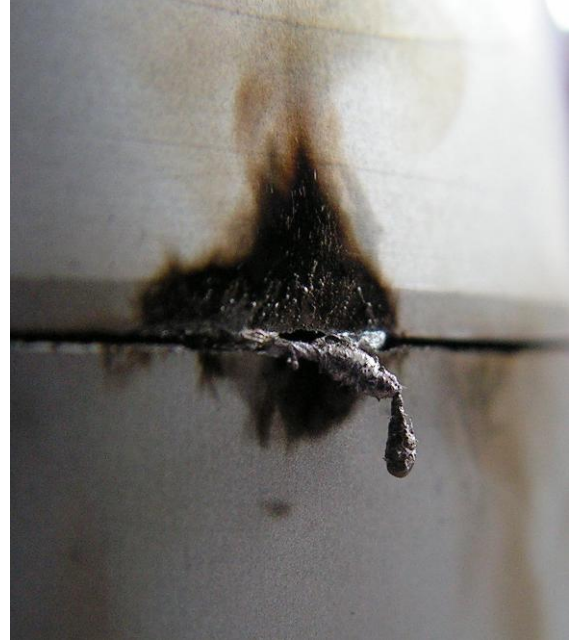
**Fig. 6.** 8/10 $\mu$ s 55kA surge current result on the flagstaff interconnection point between sections

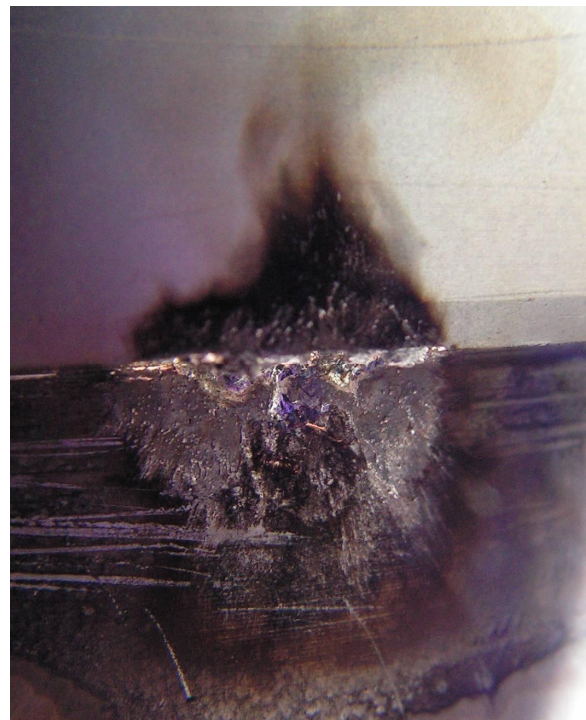
**Fig. 7.** 8/10 $\mu$ s 55kA surge current result on the flagstaff interconnection point between sections

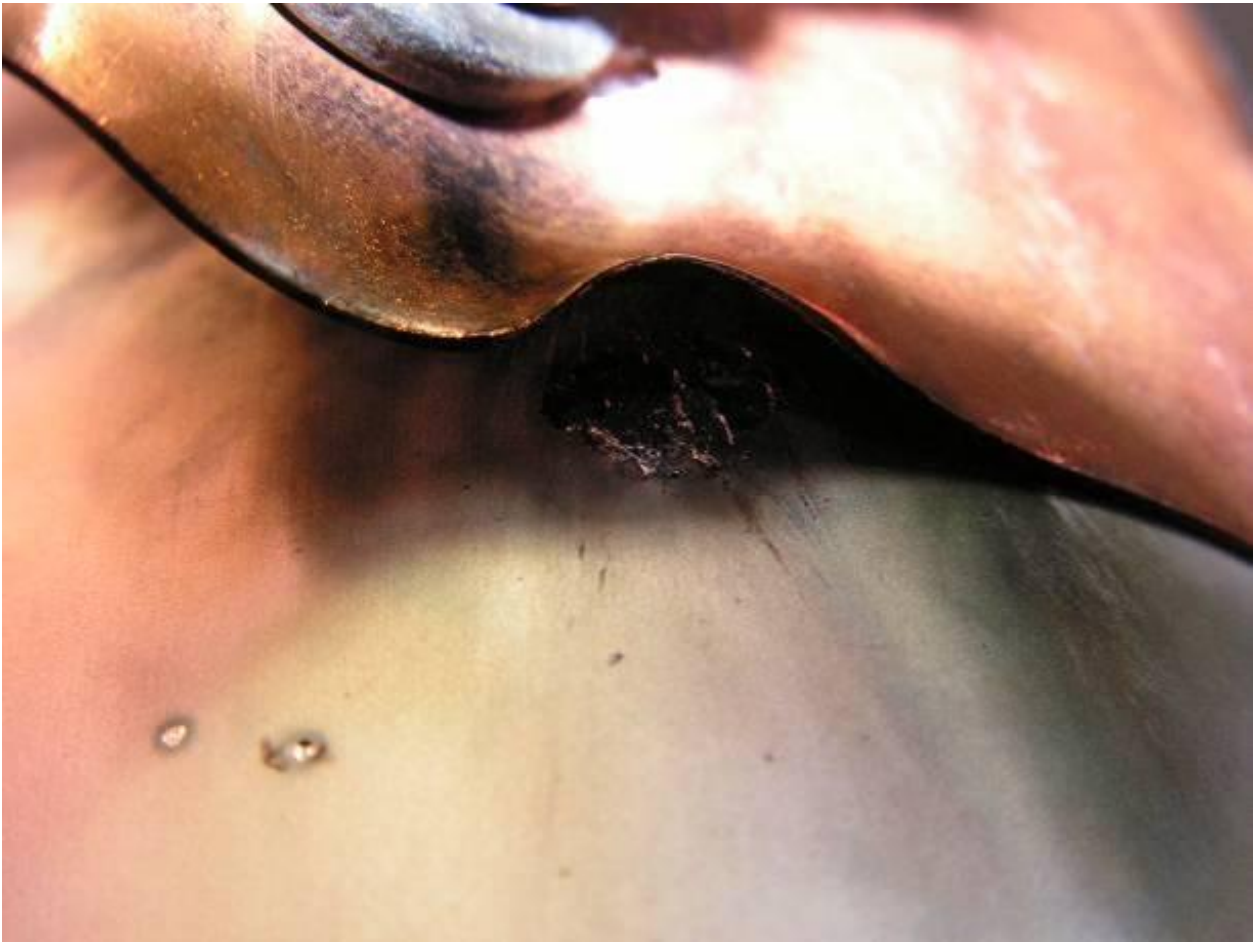
**Fig. 8.** 8/10µs 55kA surge current result on the flagstaff interconnection point between section and ground

- made a solid interconnection between the flagstaff sections
- add wire inside flagstaff to force surge current to flow inside, not by the outside flagstaff surface
- to improve human being safety flagstaff should be well grounded by the solid connection (step and touch voltage reduction). Restore shouldn't be used – fig.8.
