## FIRE PROTECTION SYSTEM DURING DISTURBANCES CAUSED BY LIGHTNING STROKE

**Abstract** – Modern fire protection systems realize many functions. First one is to signal and remotely inform when fire appears. Second one is to turn on extinguishing system also very important. Lightning strike to the building lightning protection system or nearby can be dangerous for fire protection system installed inside this building. Any malfunction of this system can cause large financial damage by needlessly turn on or not turn on the extinguishing system.

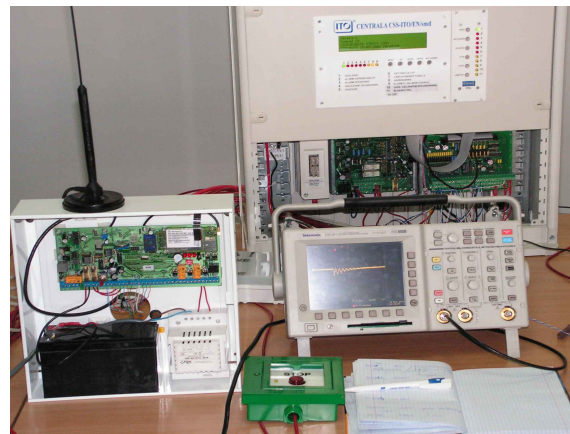
All tests were performed on the real fire protection system, which consists of digital automatic control and indicating central, 2 fire warning sensor lines with 8 standard fire sensors, 1 laser fire detector – 1000 times more sensitive than standard one, helper systems, GSM data exchange system and status printer (Fig. 1).

Fig. 1 - Fire protection system during the EMC tests.
